# CLOSING THE ENFORCEMENT GAP

A community-led groundtruthing of the expansion  
of a National Highway in Uttara Kannada

A groundtruthing study of the social and environmental impacts and legal non-compliance of the National Highway expansion project in coastal Uttara Kannada, Karnataka

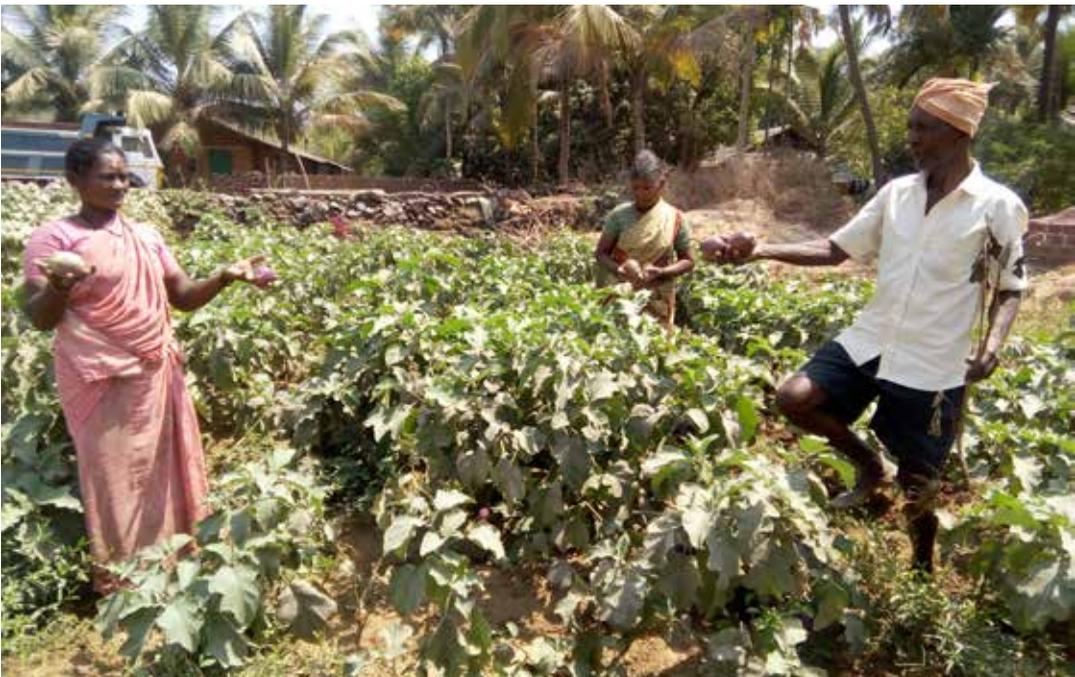
Residents of Bogribail village showing damaged crops due to dust pollution, Photo credit: Maruti Gouda

near Bhatkal, 12 houses had been damaged by heavy blasting activities and several farmlands were covered in a layer of dust. In Shetageri, village residents were deprived of access to forest land because of blasting activities taking place along their usual route and the cattle-grazing lands had been affected by the dust that was generated from the blasting.

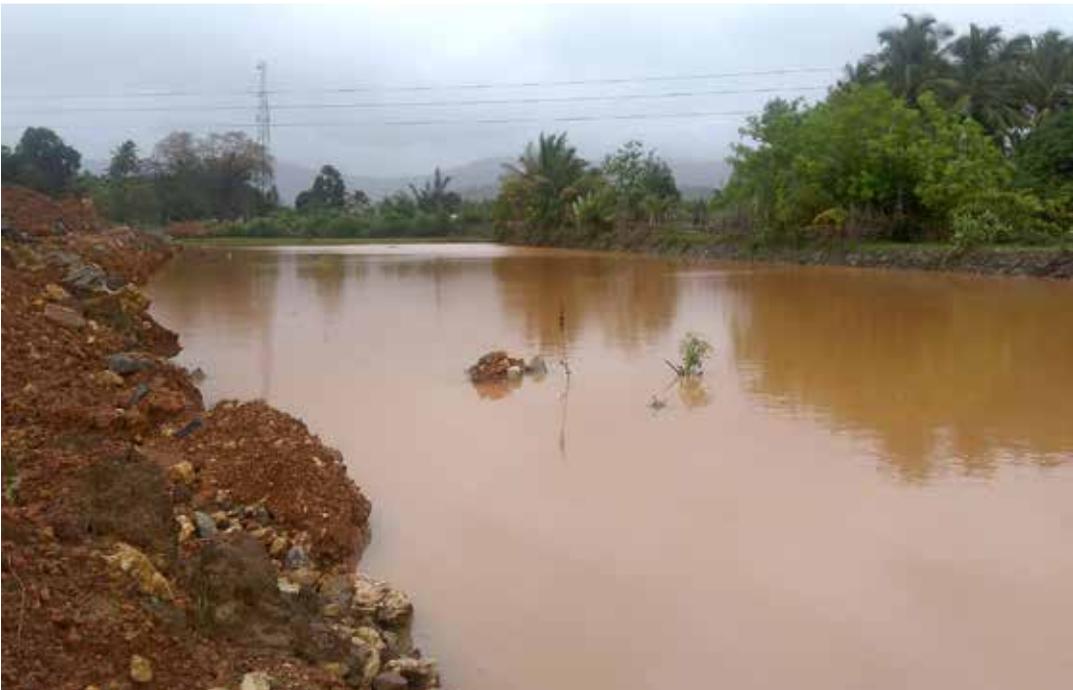
In Belase village near Ankola, more than 30 acres of agricultural land was submerged due to floods in June 2018. Residents explained that the highway passed through their farm land and the height of the road was elevated by 5 feet by filling it up with soil. However, while filling up, the company did not provide any drainage facility to allow water to pass through, and this resulted in the flowing in of rain water during the beginning of the monsoon, in turn flooding the farmland. The rain water also carried with it a lot of eroded soil from the mountains, which settled in the agricultural lands, leading to increased siltation. Because of this non-compliance and its impact, around 60 families of Belase village lost the entire season's crop, and since their land had not been acquired, they did not receive any compensation. In July 2017, around 30 families of Salikeri village near Honnavar lost the season's crop as a result of similar flooding. The farmers approached the local panchayat for remedial measures. The panchayat in turn undertook remedial measures and facilitated the removal of the material which had been dumped in the creeks and streams so as to avoid any flooding in the future.

Flooding in Belase Village, Photo credit: Maruti Gouda

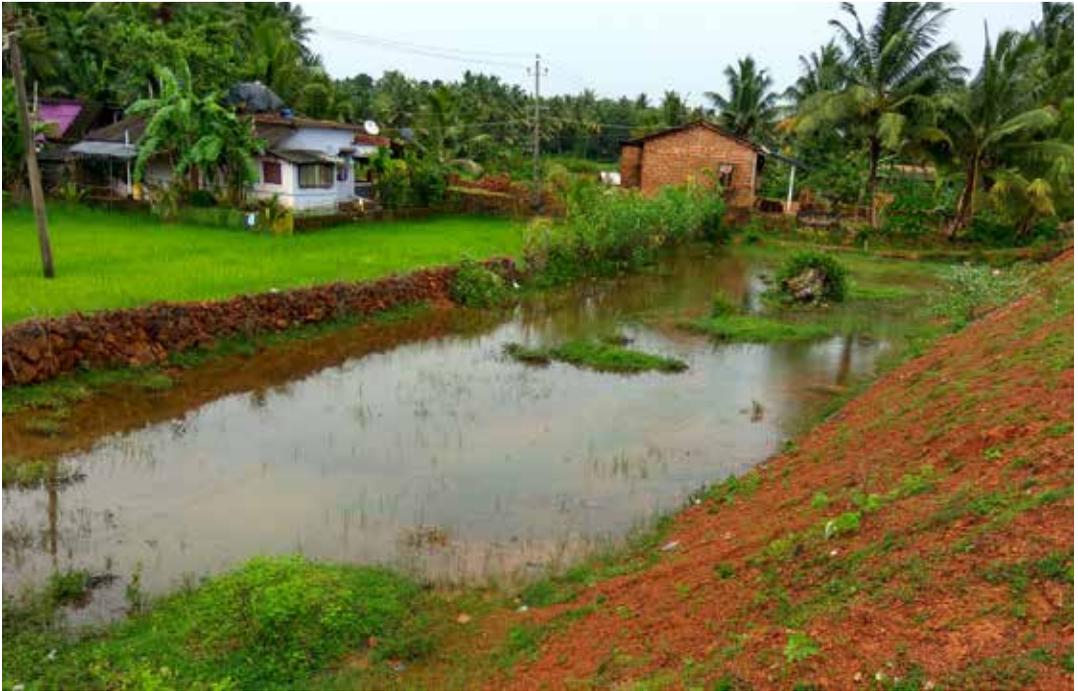
Another problem which resulted in saltwater intrusion and flooding was also linked to the project. The EC specifies that soil must not be dumped on wetlands. This condition was violated on several occasions in several locations by the project

Blockage of creek in Haldipur village, Photo credit: Vinod Patgar

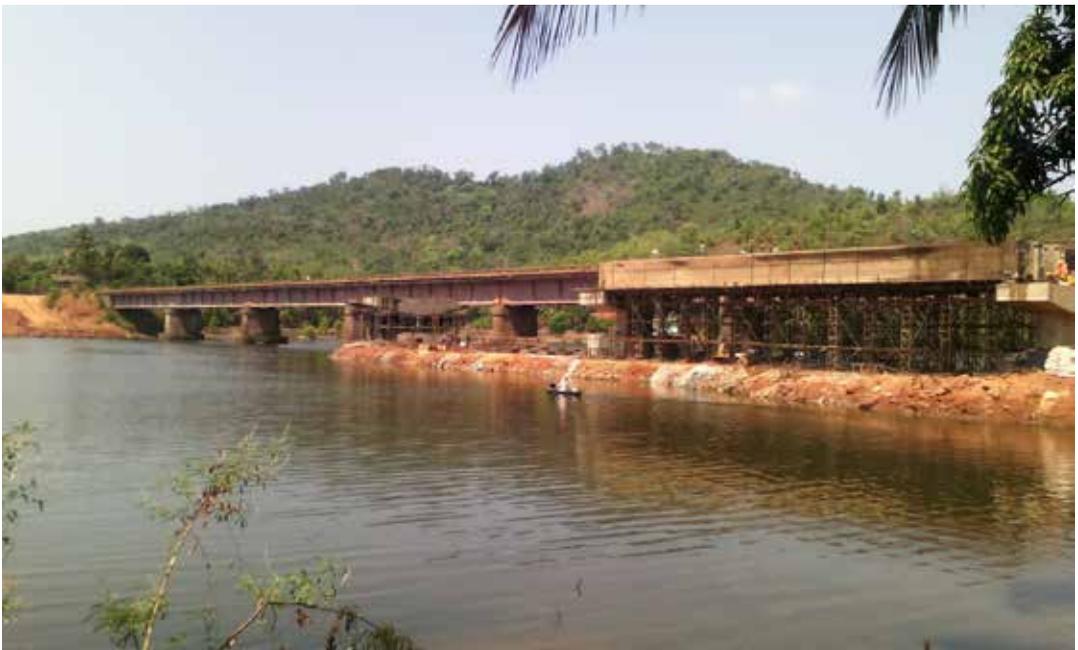
Blockage of Gangavali River due to bridge construction, Photo credit: Maruti Gouda

in the Ankola taluk. When the construction of the bridge was carried out over Gangavali River as part of the NH expansion, the river flow was blocked due to dumping of soil. This impacted the tidal flow pattern of the river and resulted in saltwater intrusion. This affected 300 acres of farmland, which was used to cultivate rice, groundnut, onions and other vegetables, rendering it unsuitable for cultivation.<sup>25</sup> Water also entered houses and coconut fields during the spring tide in October 2016.

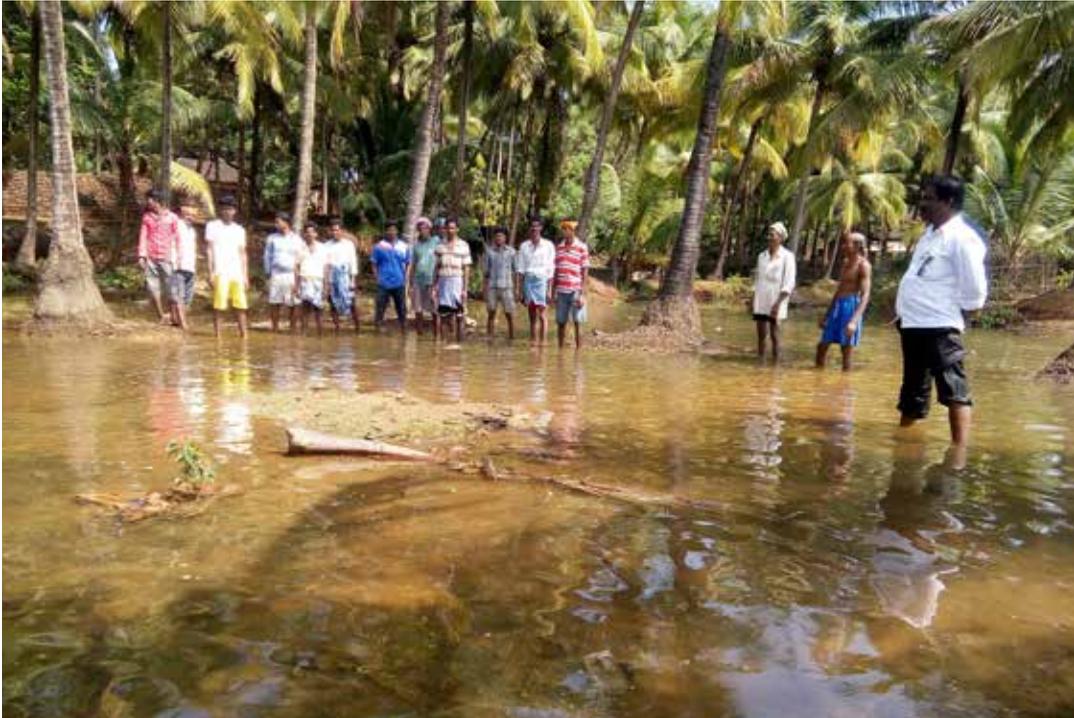
proponent and this created serious flooding and saltwater intrusion-related problems for people who live near rivers or creeks. One such example is Chandumata village where saltwater intrusion took place in 2016. In Chandumata, which is located on the banks of Gangavali River, fertile agricultural land is cultivated by nearly 300 farmers

Salt water intrusion in Chandumata village, Photo credit: Maruti Gouda

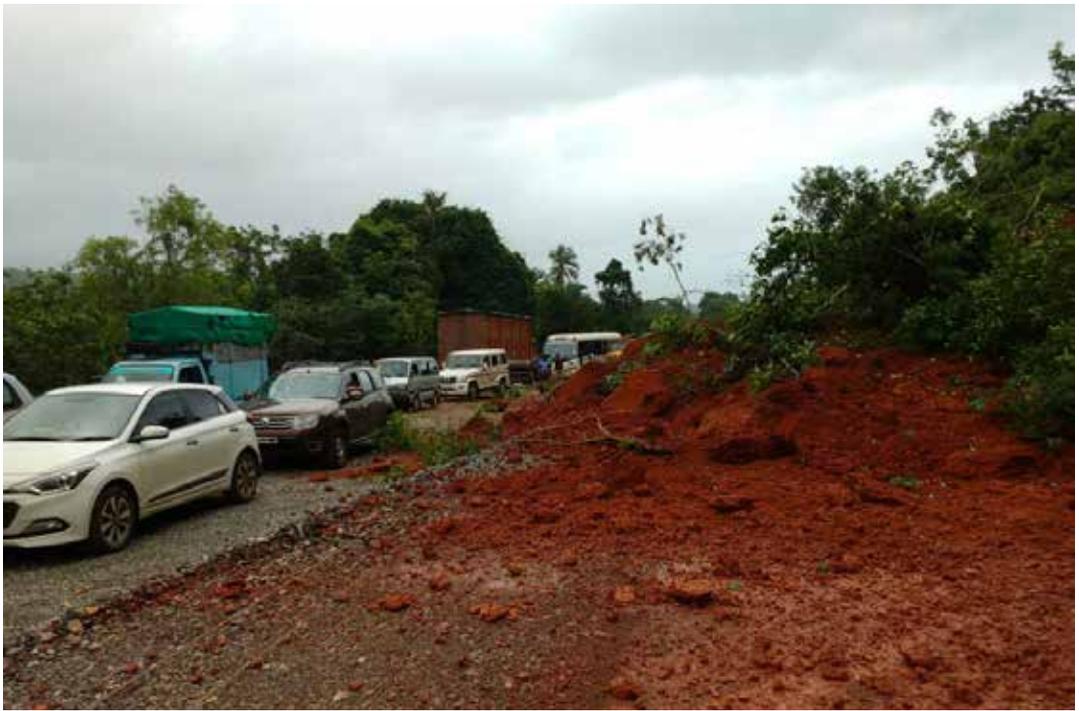
During the study, several newspaper reports and site visits by the study team revealed that the project concessionaire had not been planting vegetation along the slopes and embankments although the same was required by the EC. This was observed in several places and as a result of this non-compliance, serious soil erosion and landslides were reported several times in the last four years. The soil erosion and landslides resulted in blockage of the road and increased siltation in the farm land.

Landslide near Dundakuli village, Photo credit: Maruti Gouda

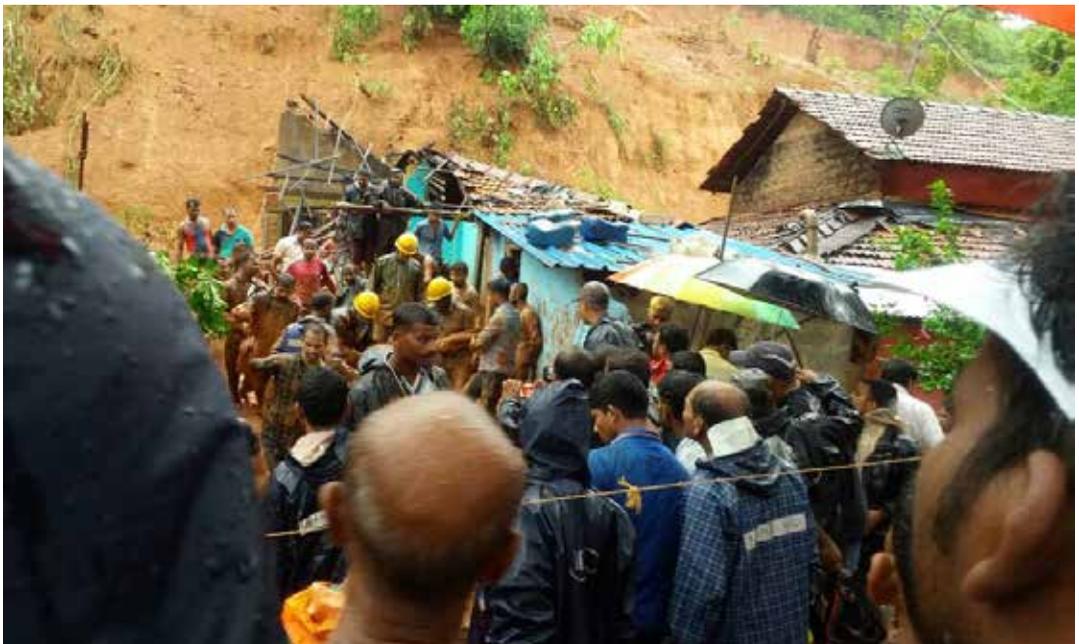
Additionally, the project concessionaire also created embankments and slopes along the mountains for widening the road which were left uncovered. In June 2017, one such huge mountain slope near Divgi village collapsed and slid down to the village. This particular landslide completely destroyed 8 houses and killed 3 children who were

3 children died and 10-15 houses were damaged to the landslide near Divgi village, Photo credit: Maruti Gouda

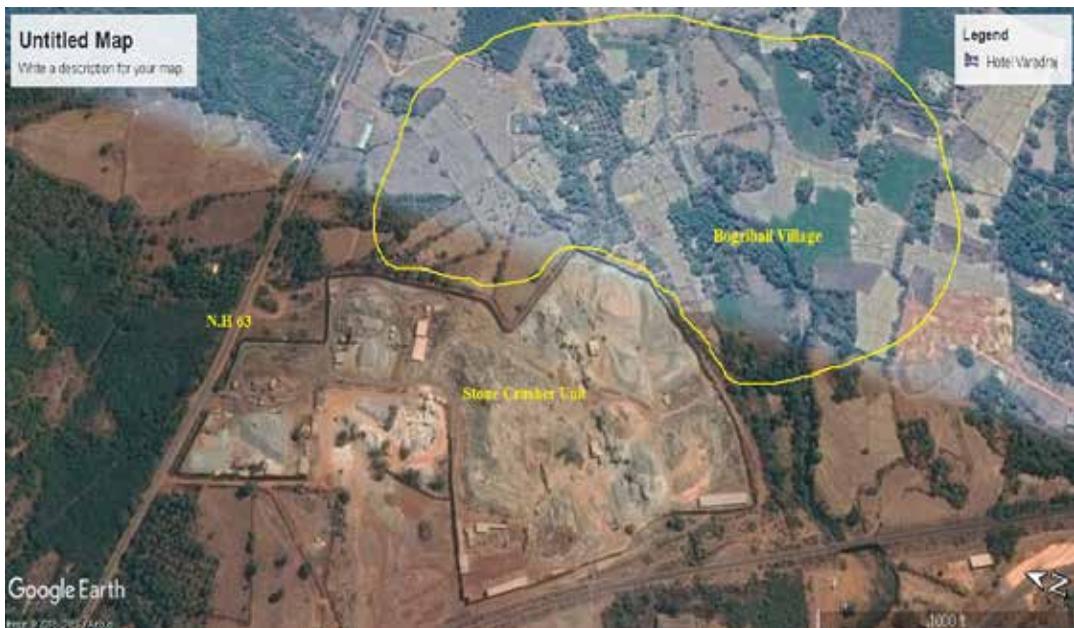
The EC conditions and the Karnataka Regulation for Stone Crushers Act of 2011 specify that secondary units such as stone crushers or hot-tar mix plants are required to be at least 500 mts from human habitation. Four major stone crusher units were operational for this project. The study shows that violation of the above requirement took place in two units: a stone crusher unit and hot-tar mix plant in Bogribail village near Ankola, and a stone blasting and stone crusher unit in Mavinkatta village near Bhatkal. The stone crusher unit in Ankola violated section 6 (1) (a), (b) and (c) of Karnataka Regulation for Stone Crushers Act, 2011 that states that a stone crusher unit shall be located (a) 200 mts away from national and state highways, (b) 100 mts away from major district roads and other roads, and (c) 500 mts away from revenue villages, temples and schools. In Bogribail, the stone crusher unit and hot-tar mix plant were constructed only 20 mts away from the village, 60 mts away from nursery schools and 10 mts away from NH-63.

The crusher unit has been operational since 2014. It operates for sixteen hours a day, causing serious dust and noise pollution in the village.<sup>26</sup> Around 200 farmers belonging to 60 families are dependent on farming which has been affected by the dust pollution created by the unit. Farmers in Bogribail village grow cashew, mango, vegetables and coconut. In the flowering season between January to March, due to dust accumulation on the flowers, the yield has reduced to 50% over the years.

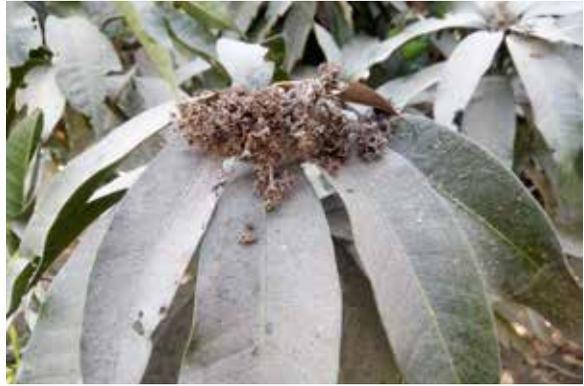
Collapsed mango crops due to dust pollution in Bogribail village, Photo credit: Maruti Gouda

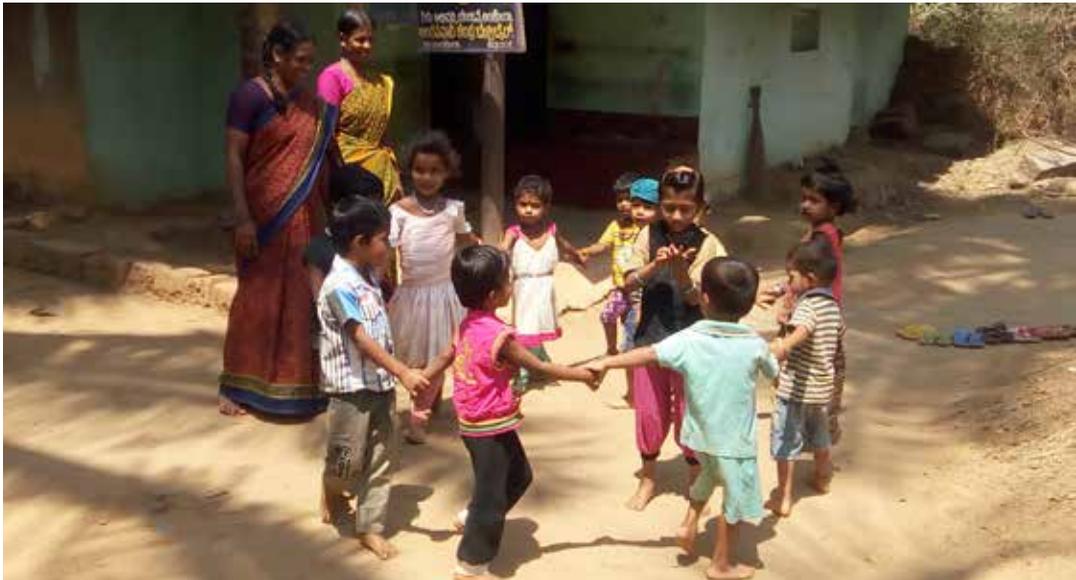
Nursery school children playing near stone crusher unit, Photo credit: Maruti Gouda

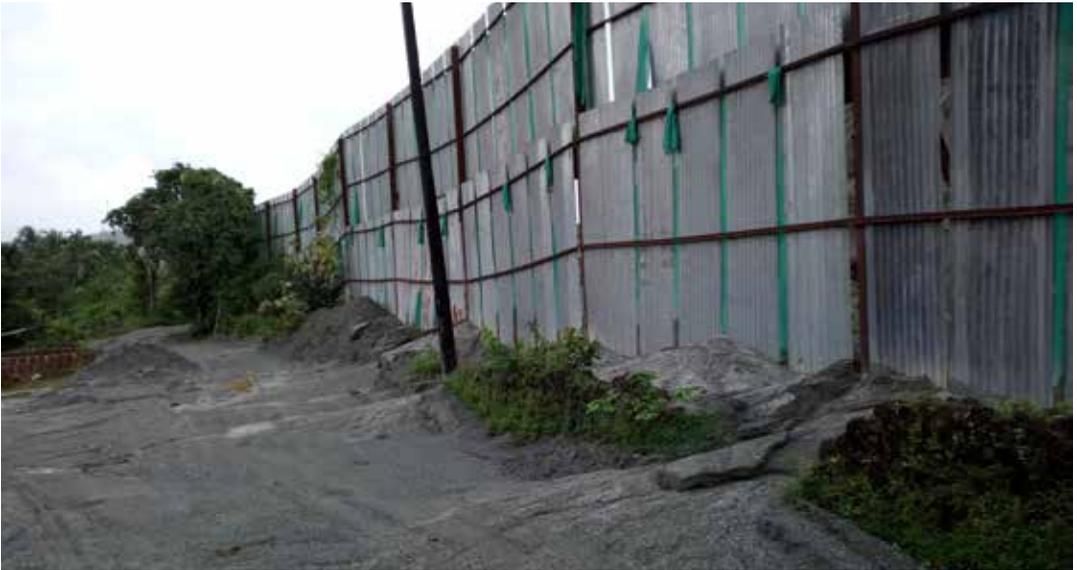
The unit is located near a water body and agricultural land, but a restraining wall has not been installed. Therefore, dust enters the water body during monsoon, and also contaminates the agricultural land. Due to non-compliance of this condition, residents of the village have not been able to use drinking water from open wells since last three years. Dust also accumulates on water sources used for agriculture.

Compound wall at the stone crusher unit, Photo credit: Maruti Gouda

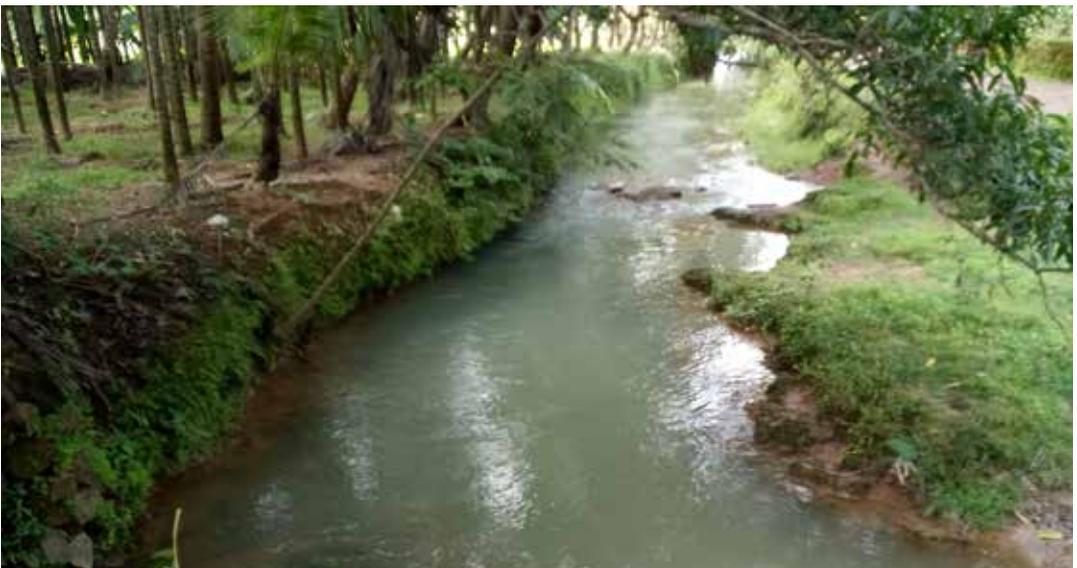
Water pollution due to stone blasting near Mavinkatta Village Bhatkal, Photo credit: Vinod Patgar

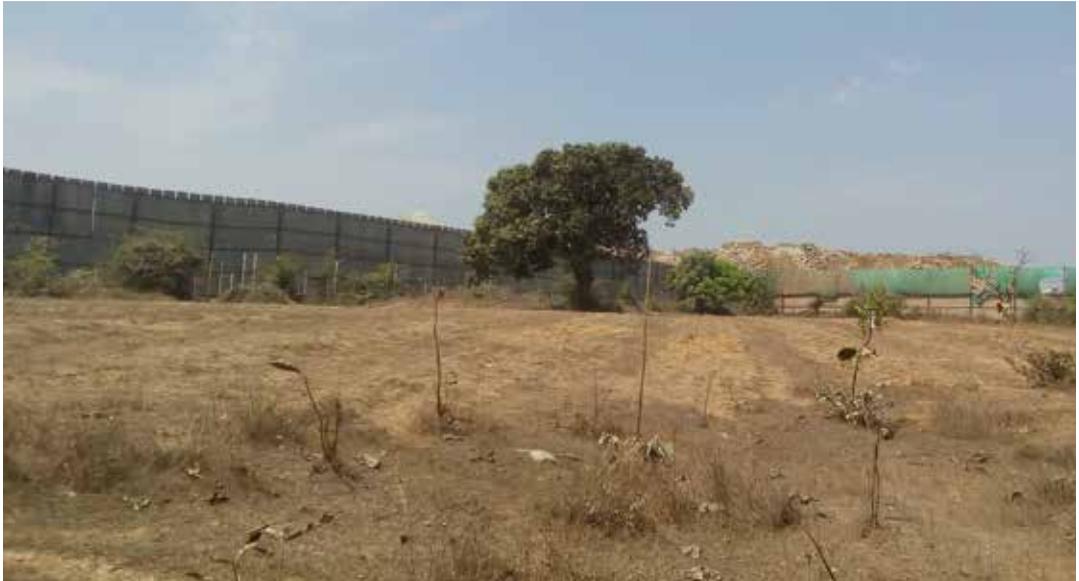
Bogribail stone crusher unit, Photo credit: Maruti Gouda

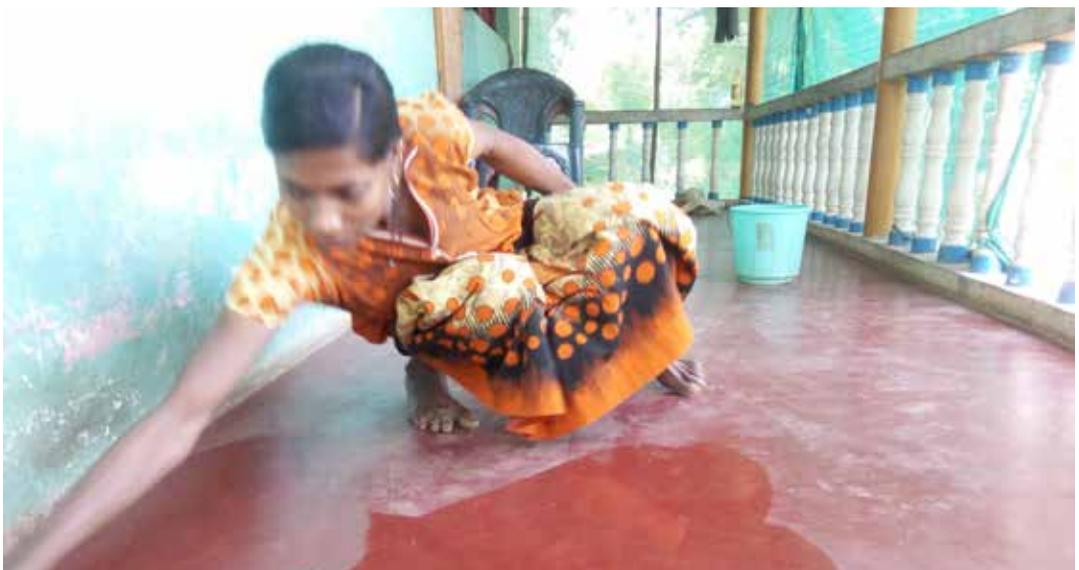
Site observations revealed that there was no such green belt or a single row of trees around the crusher unit. Non-compliance of this condition has caused serious dust pollution in Bogribail village. Dust enters the houses constantly and female residents have been complaining about not being able to keep their homes and surroundings clean.

Dust pollution due to stone crusher unit at Bogribail village Ankola, Photo credit: Maruti Gouda

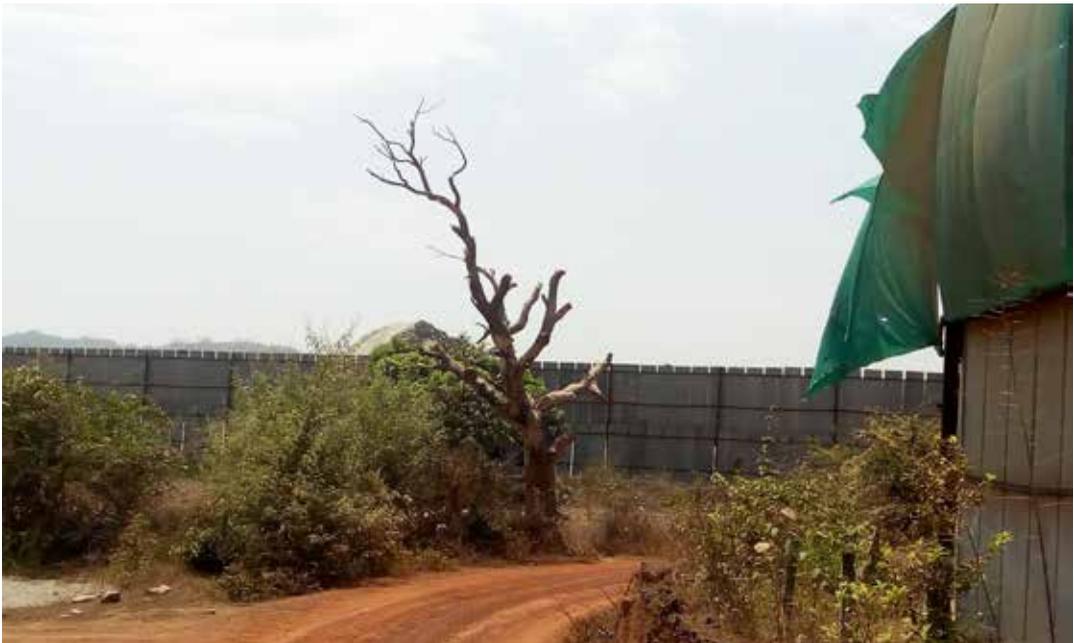
Wind breaking walls have been installed at the unit, but the walls have been damaged, and thus the pollution remains unmitigated.

No wind breaking wall at Bogribail stone crusher unit, Photo credit: Maruti Gouda

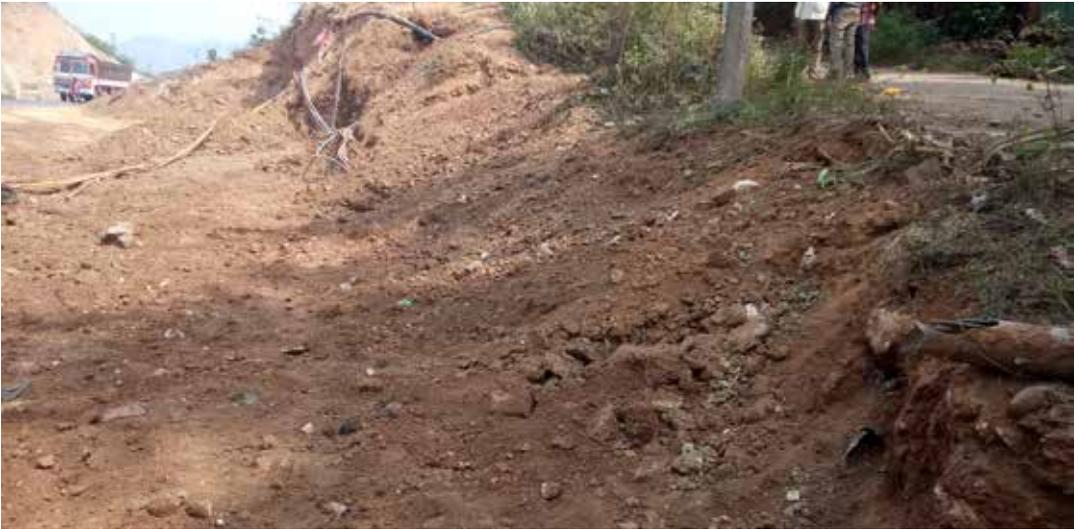
Several public utilities such as water tanks, pipelines, bore wells, schools and panchayat property were destroyed or damaged during the road construction. Complaints in this regard were filed with the NHAI, but no response has been received. One such example is in Vandige village near Ankola where a pipeline supplying drinking water was destroyed during the highway construction, and the residents were deprived of drinking water for three months in the summer of 2017. Later, the panchayat came forward to repair the pipeline.

Damaged pipeline near Vandige Village Ankola, Photo credit: Maruti Gouda

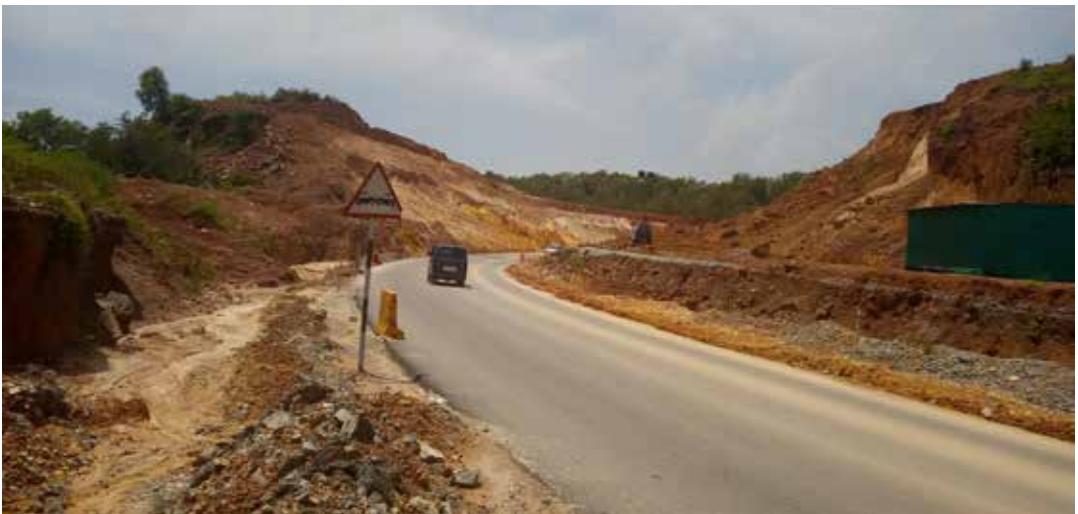
NH work in progress near Shiroor Bhatkal, Photo credit: Vinod Patgar

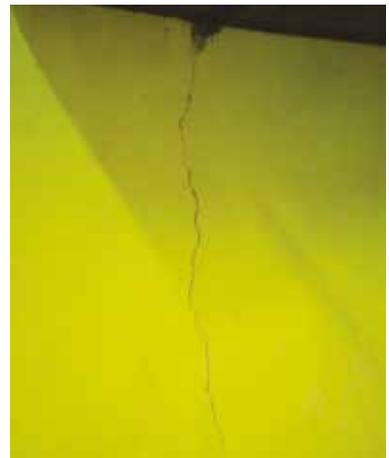
Damaged house due to stone blasting near Mavinkatta, Bhatkal  
Photo credit: Vinod Patgar

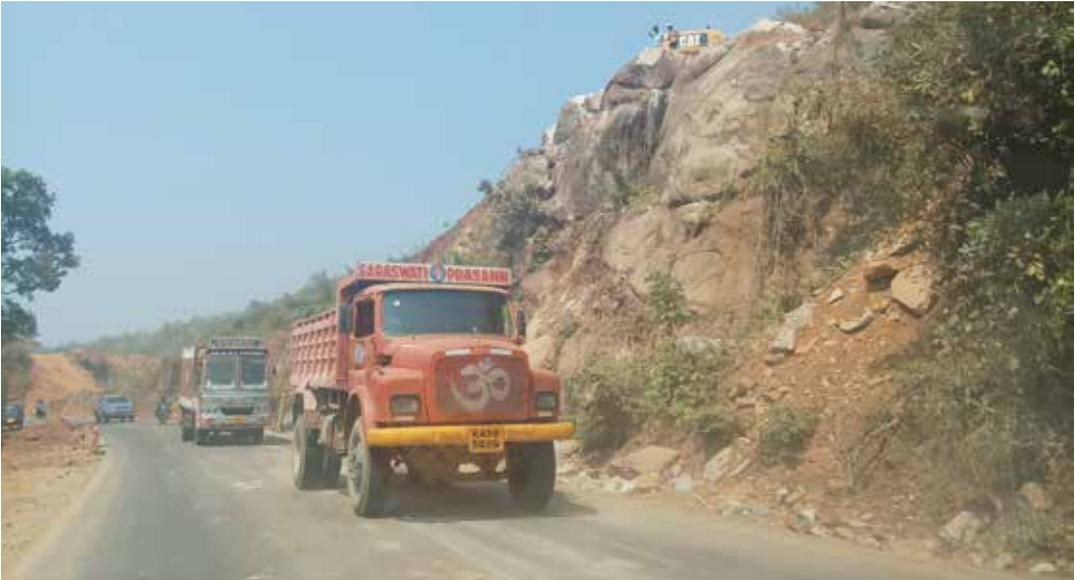
Stone blasting near Amadalli, Karwar, Photo credit: Vinod Patgar

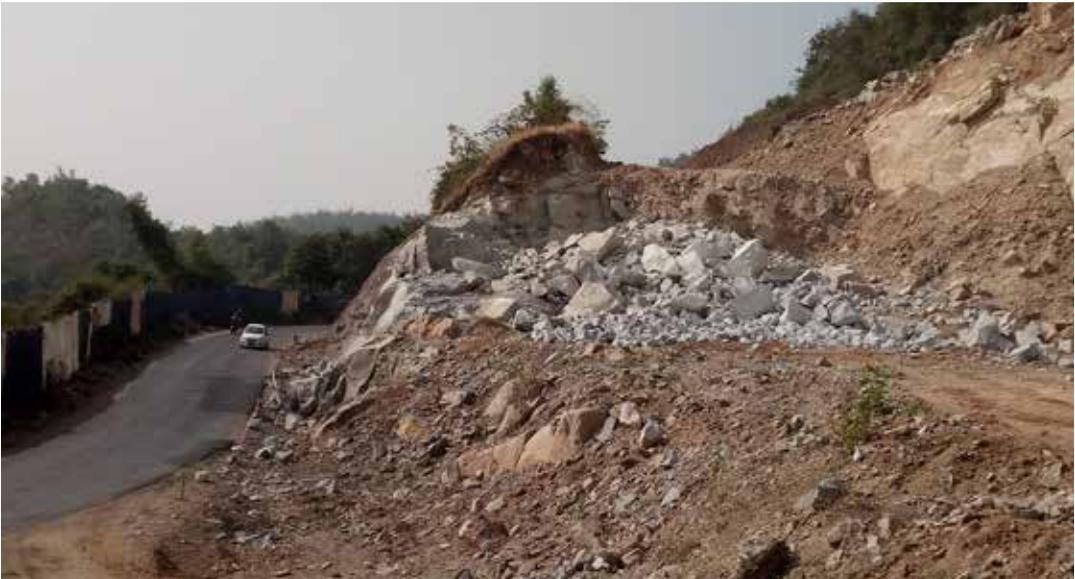
Stone Blasting near Chendiya, Karwar, Photo credit: Vinod Patgar

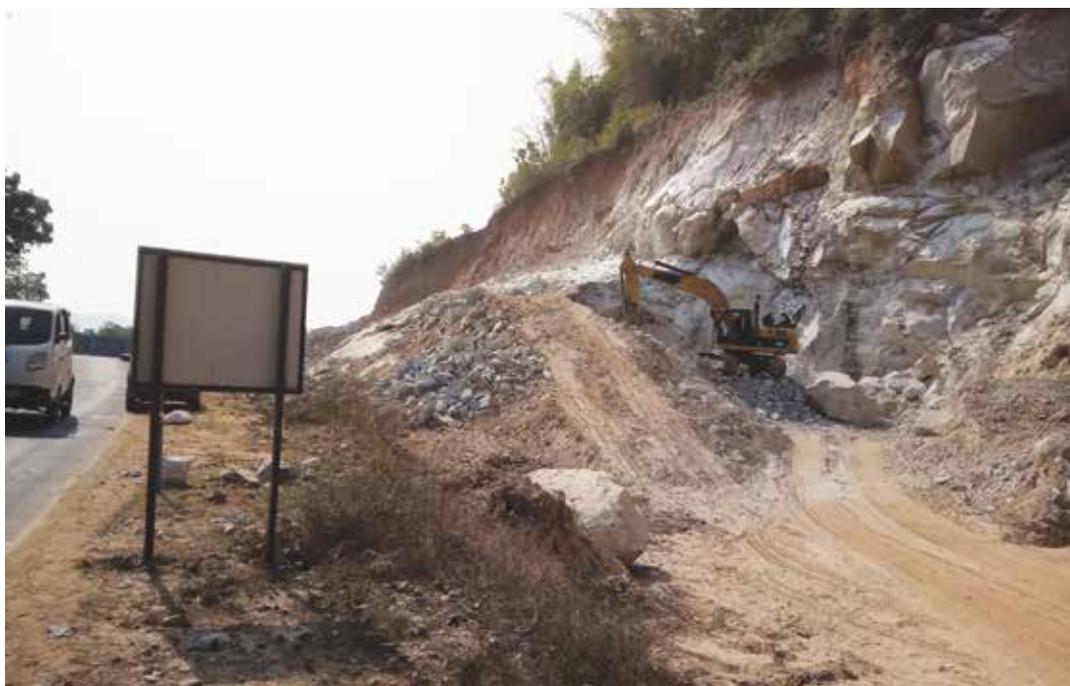
Stone blasting near Arga, Karwar, Photo credit: Vinod Patgar

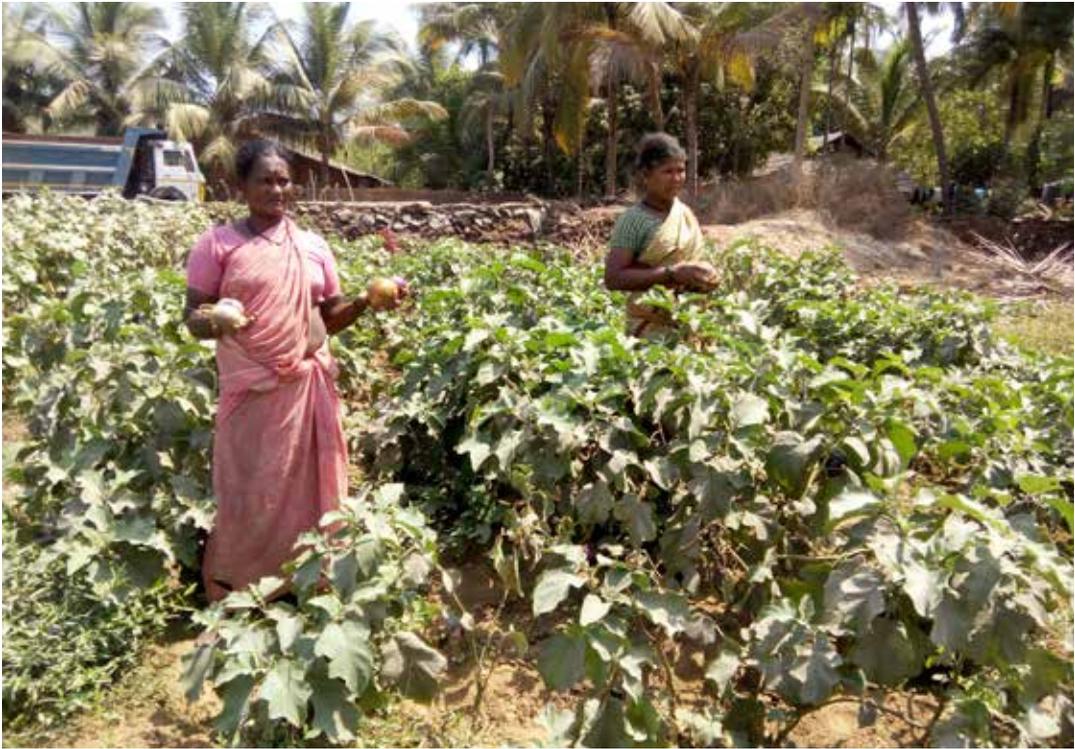
Damaged crops due to stone crusher unit at Bogribail, Ankola, Photo credit: Maruti Gouda

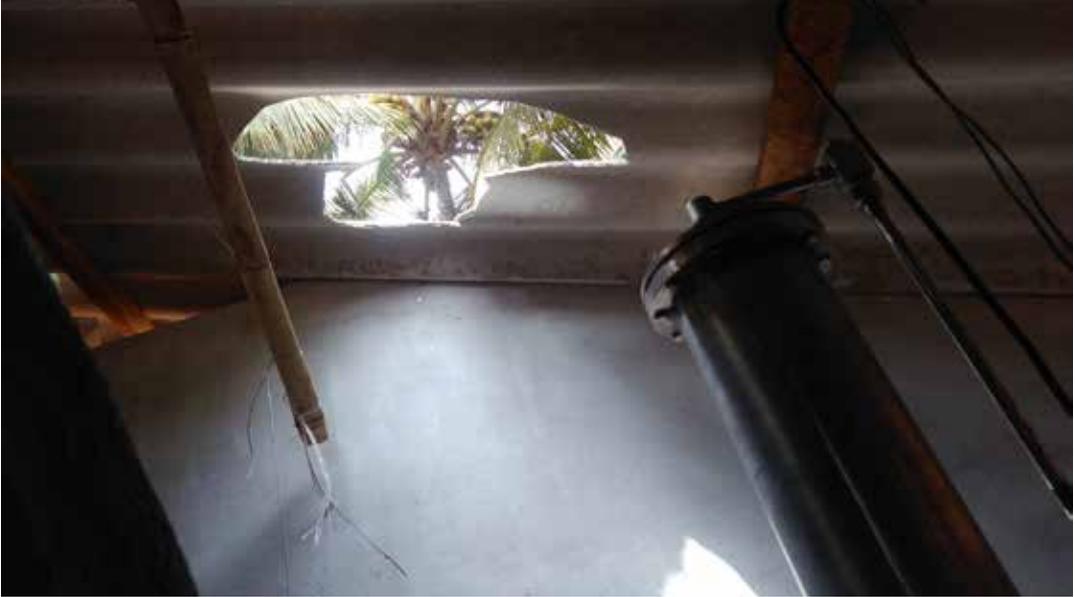
Damaged house due to stone blasting near Bogribail, Ankola, Photo credit: Maruti Gouda

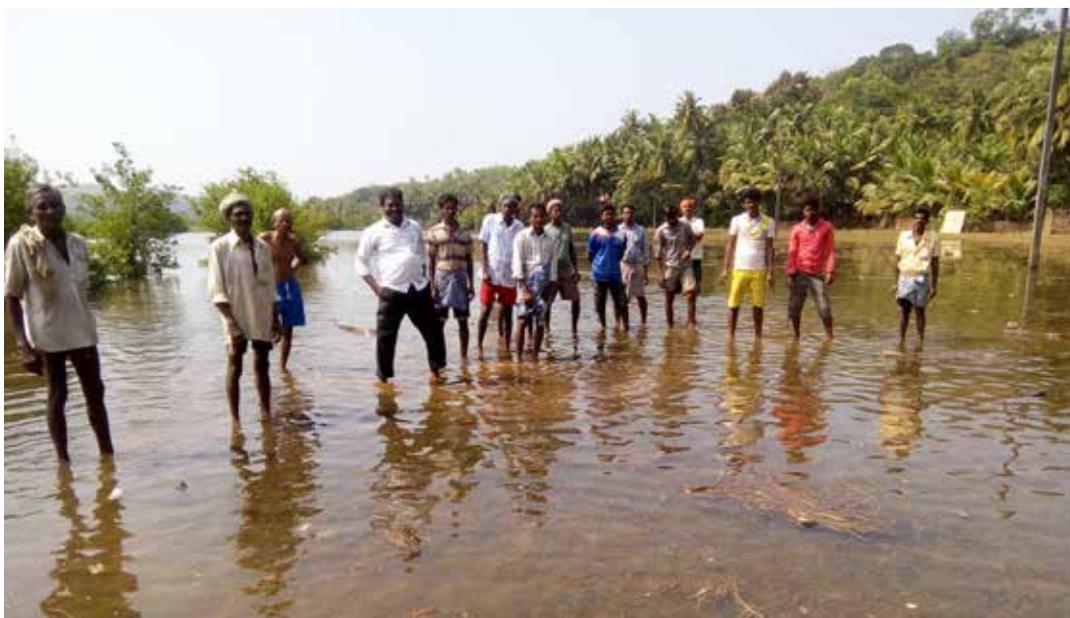
Salt water intrusion in Chandumata vilage, Photo credit: Maruti Gouda

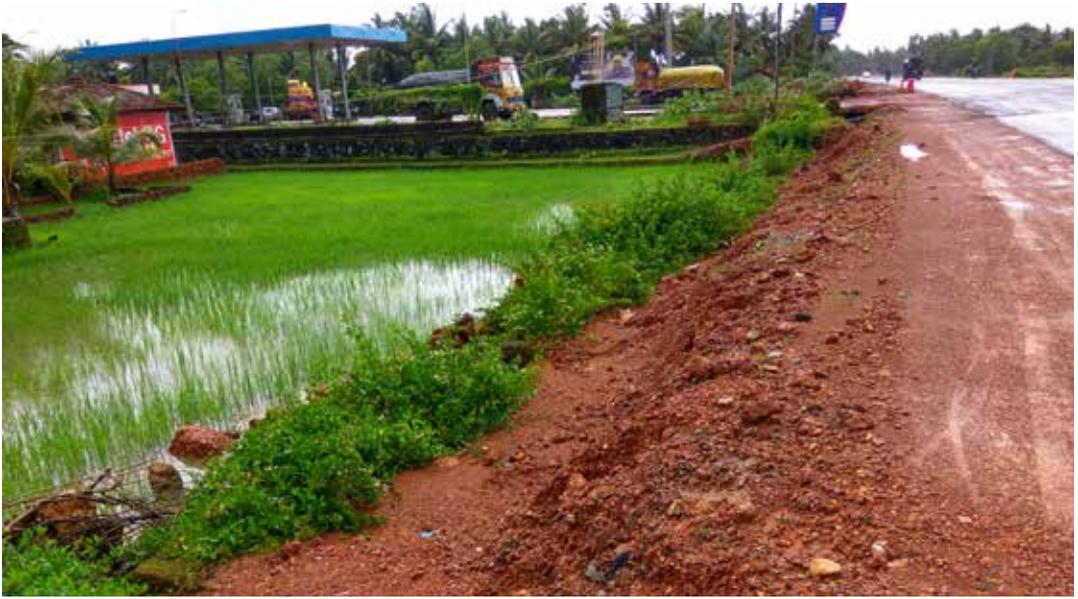
Another major set of impacts reported during the survey was flooding during the monsoons due to blockage of the water flow. There are more than 460 streams, creeks, rivers flowing from the Western Ghats and into the expanse of the coastal plain from Karwar to Kundapur. Some of them flow perennially, while many of them flow only during the monsoon season. The project proponent had promised that sufficient bridges, water underpasses and culverts would be constructed to maintain the natural water flow. However, the study revealed that the project proponent did not take into consideration many of the seasonally flowing creeks and rivers. This created a drainage problem in the coastal areas. During the construction, many streams and creeks were blocked due to the construction of the highway and some were blocked due to dumping during the construction.

Flooding due to blockage of creek near Salikeri village, Photo credit: Vinod Patgar
